File: 2018-3149.010.E.05.00

Re: 2018 SANITARY SEWER CCTV INSPECTION RESULTS & RECOMMENDED ACTIONS

SEDGEWICK
SANITARY SYSTEM

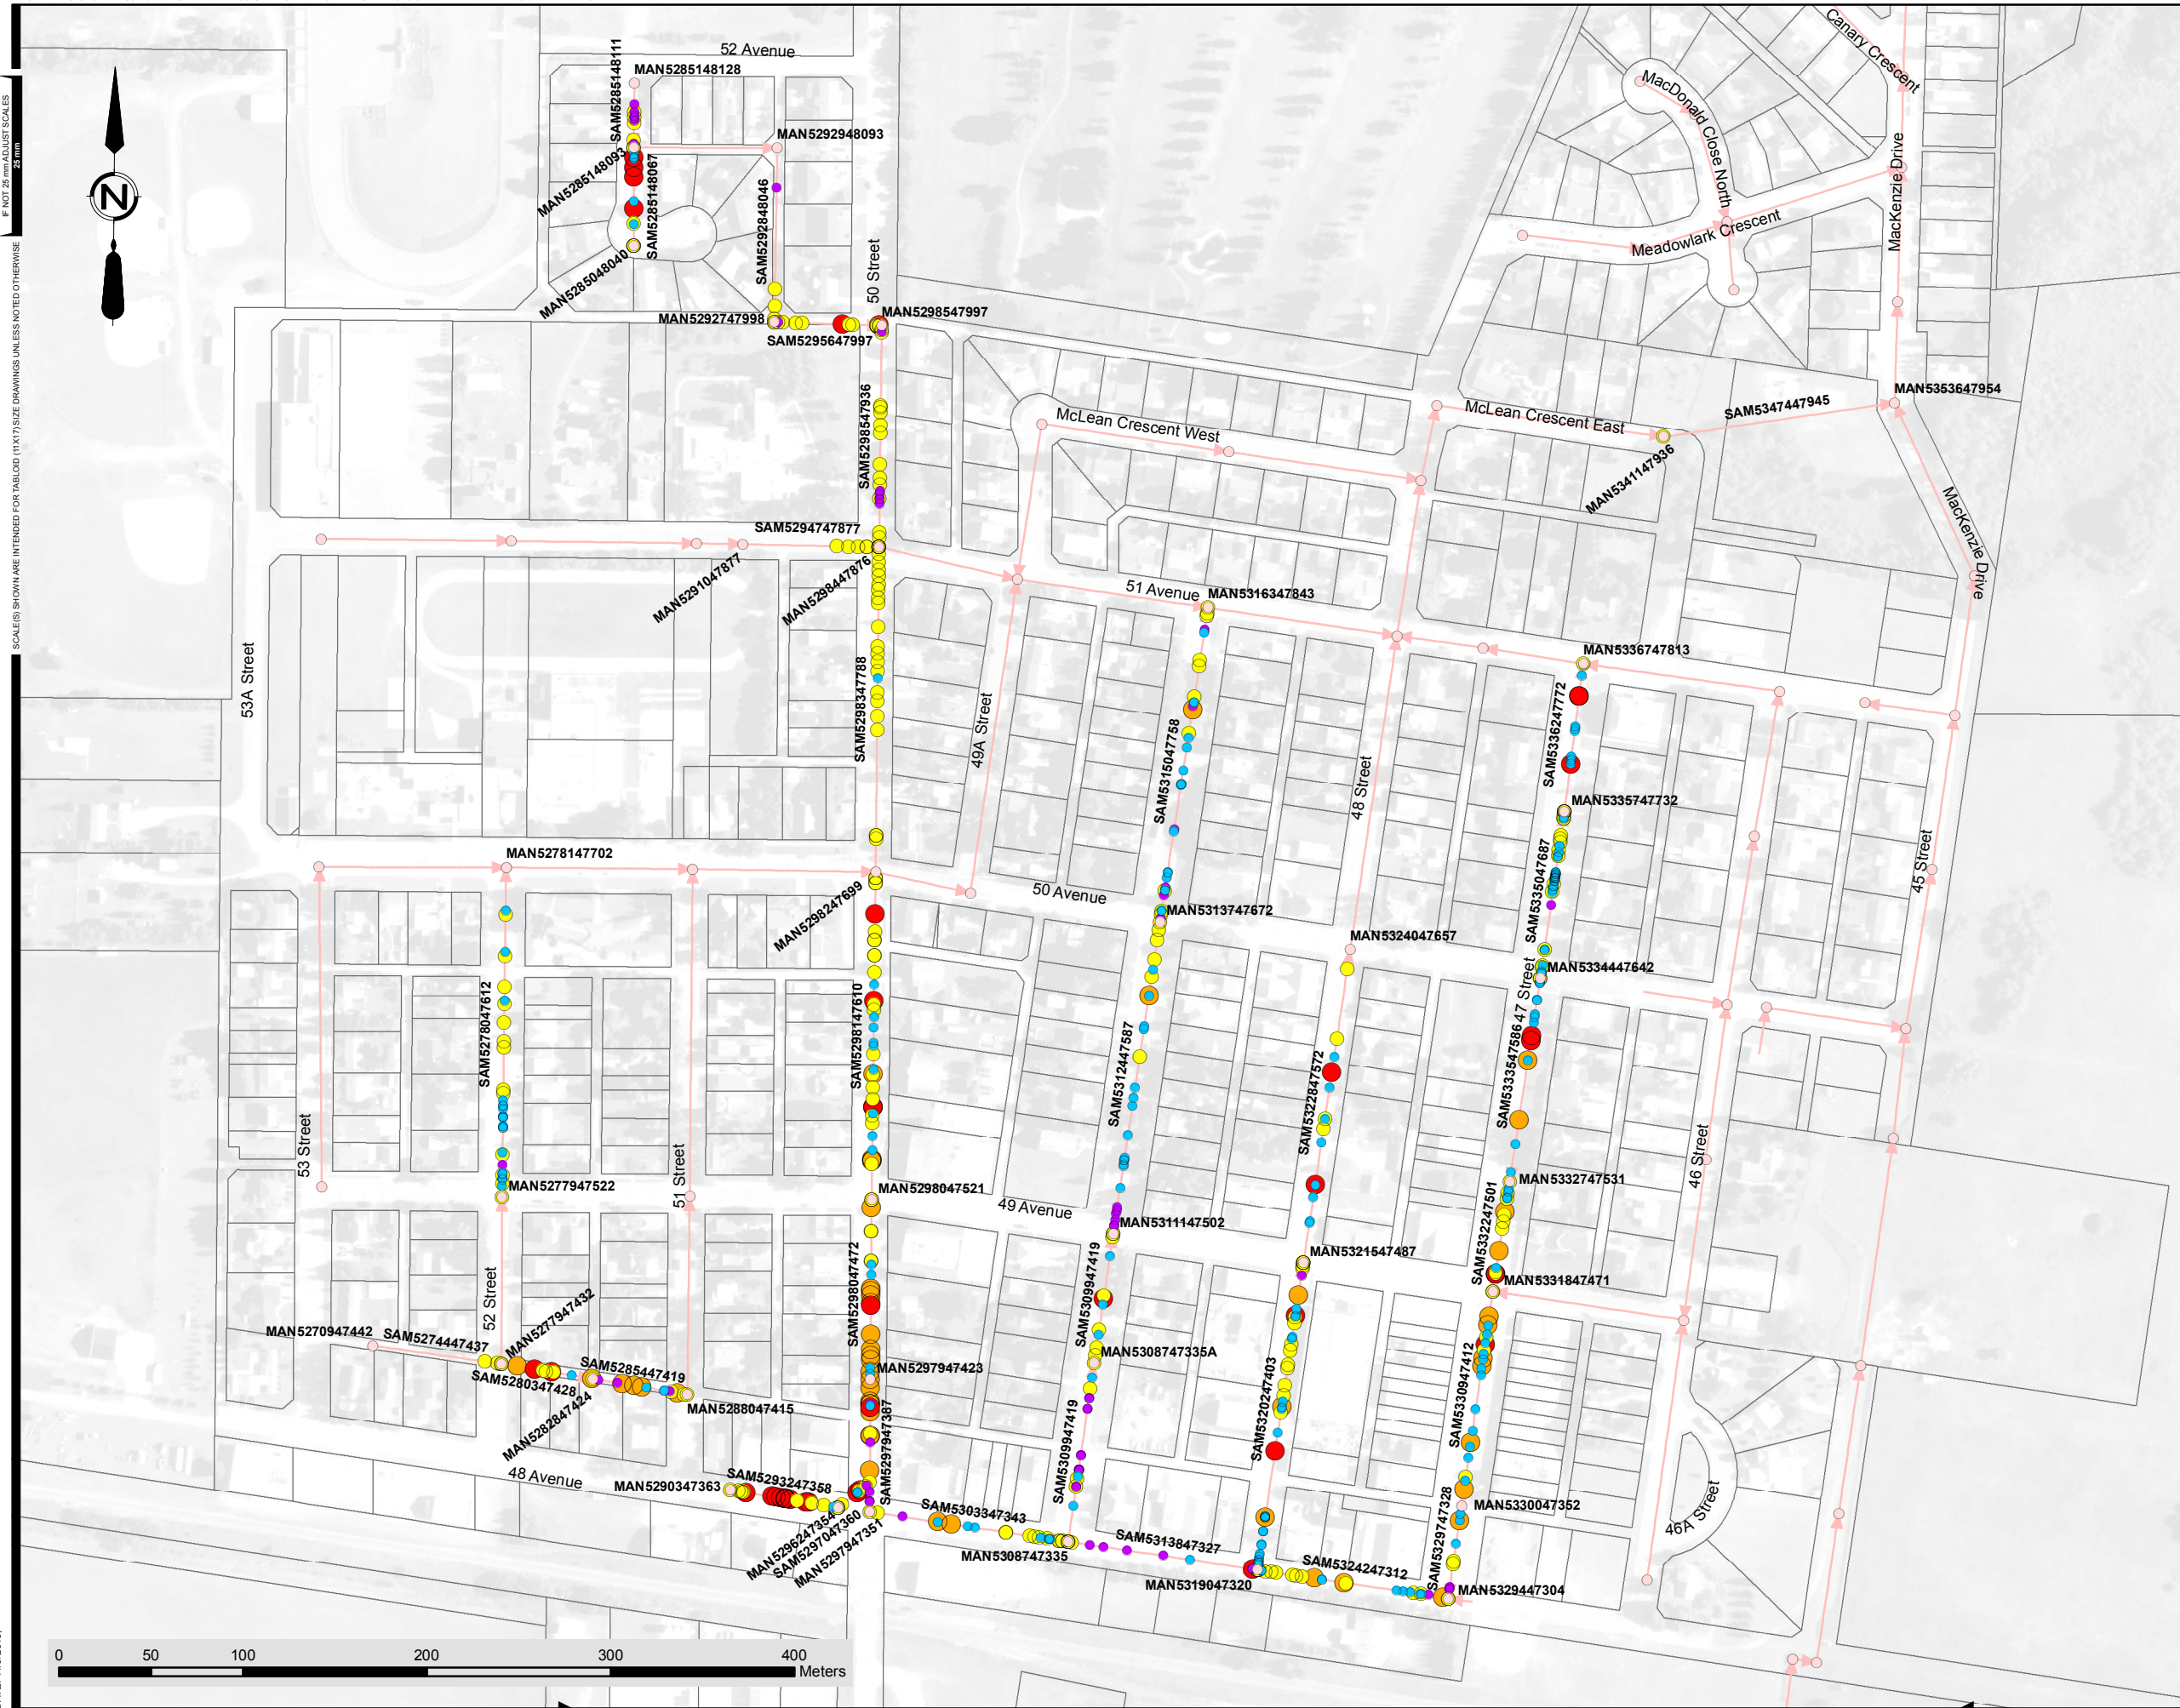
FIGURE No. 1

Figure 1 (enclosed) illustrates which pipes were inspected in 2018.

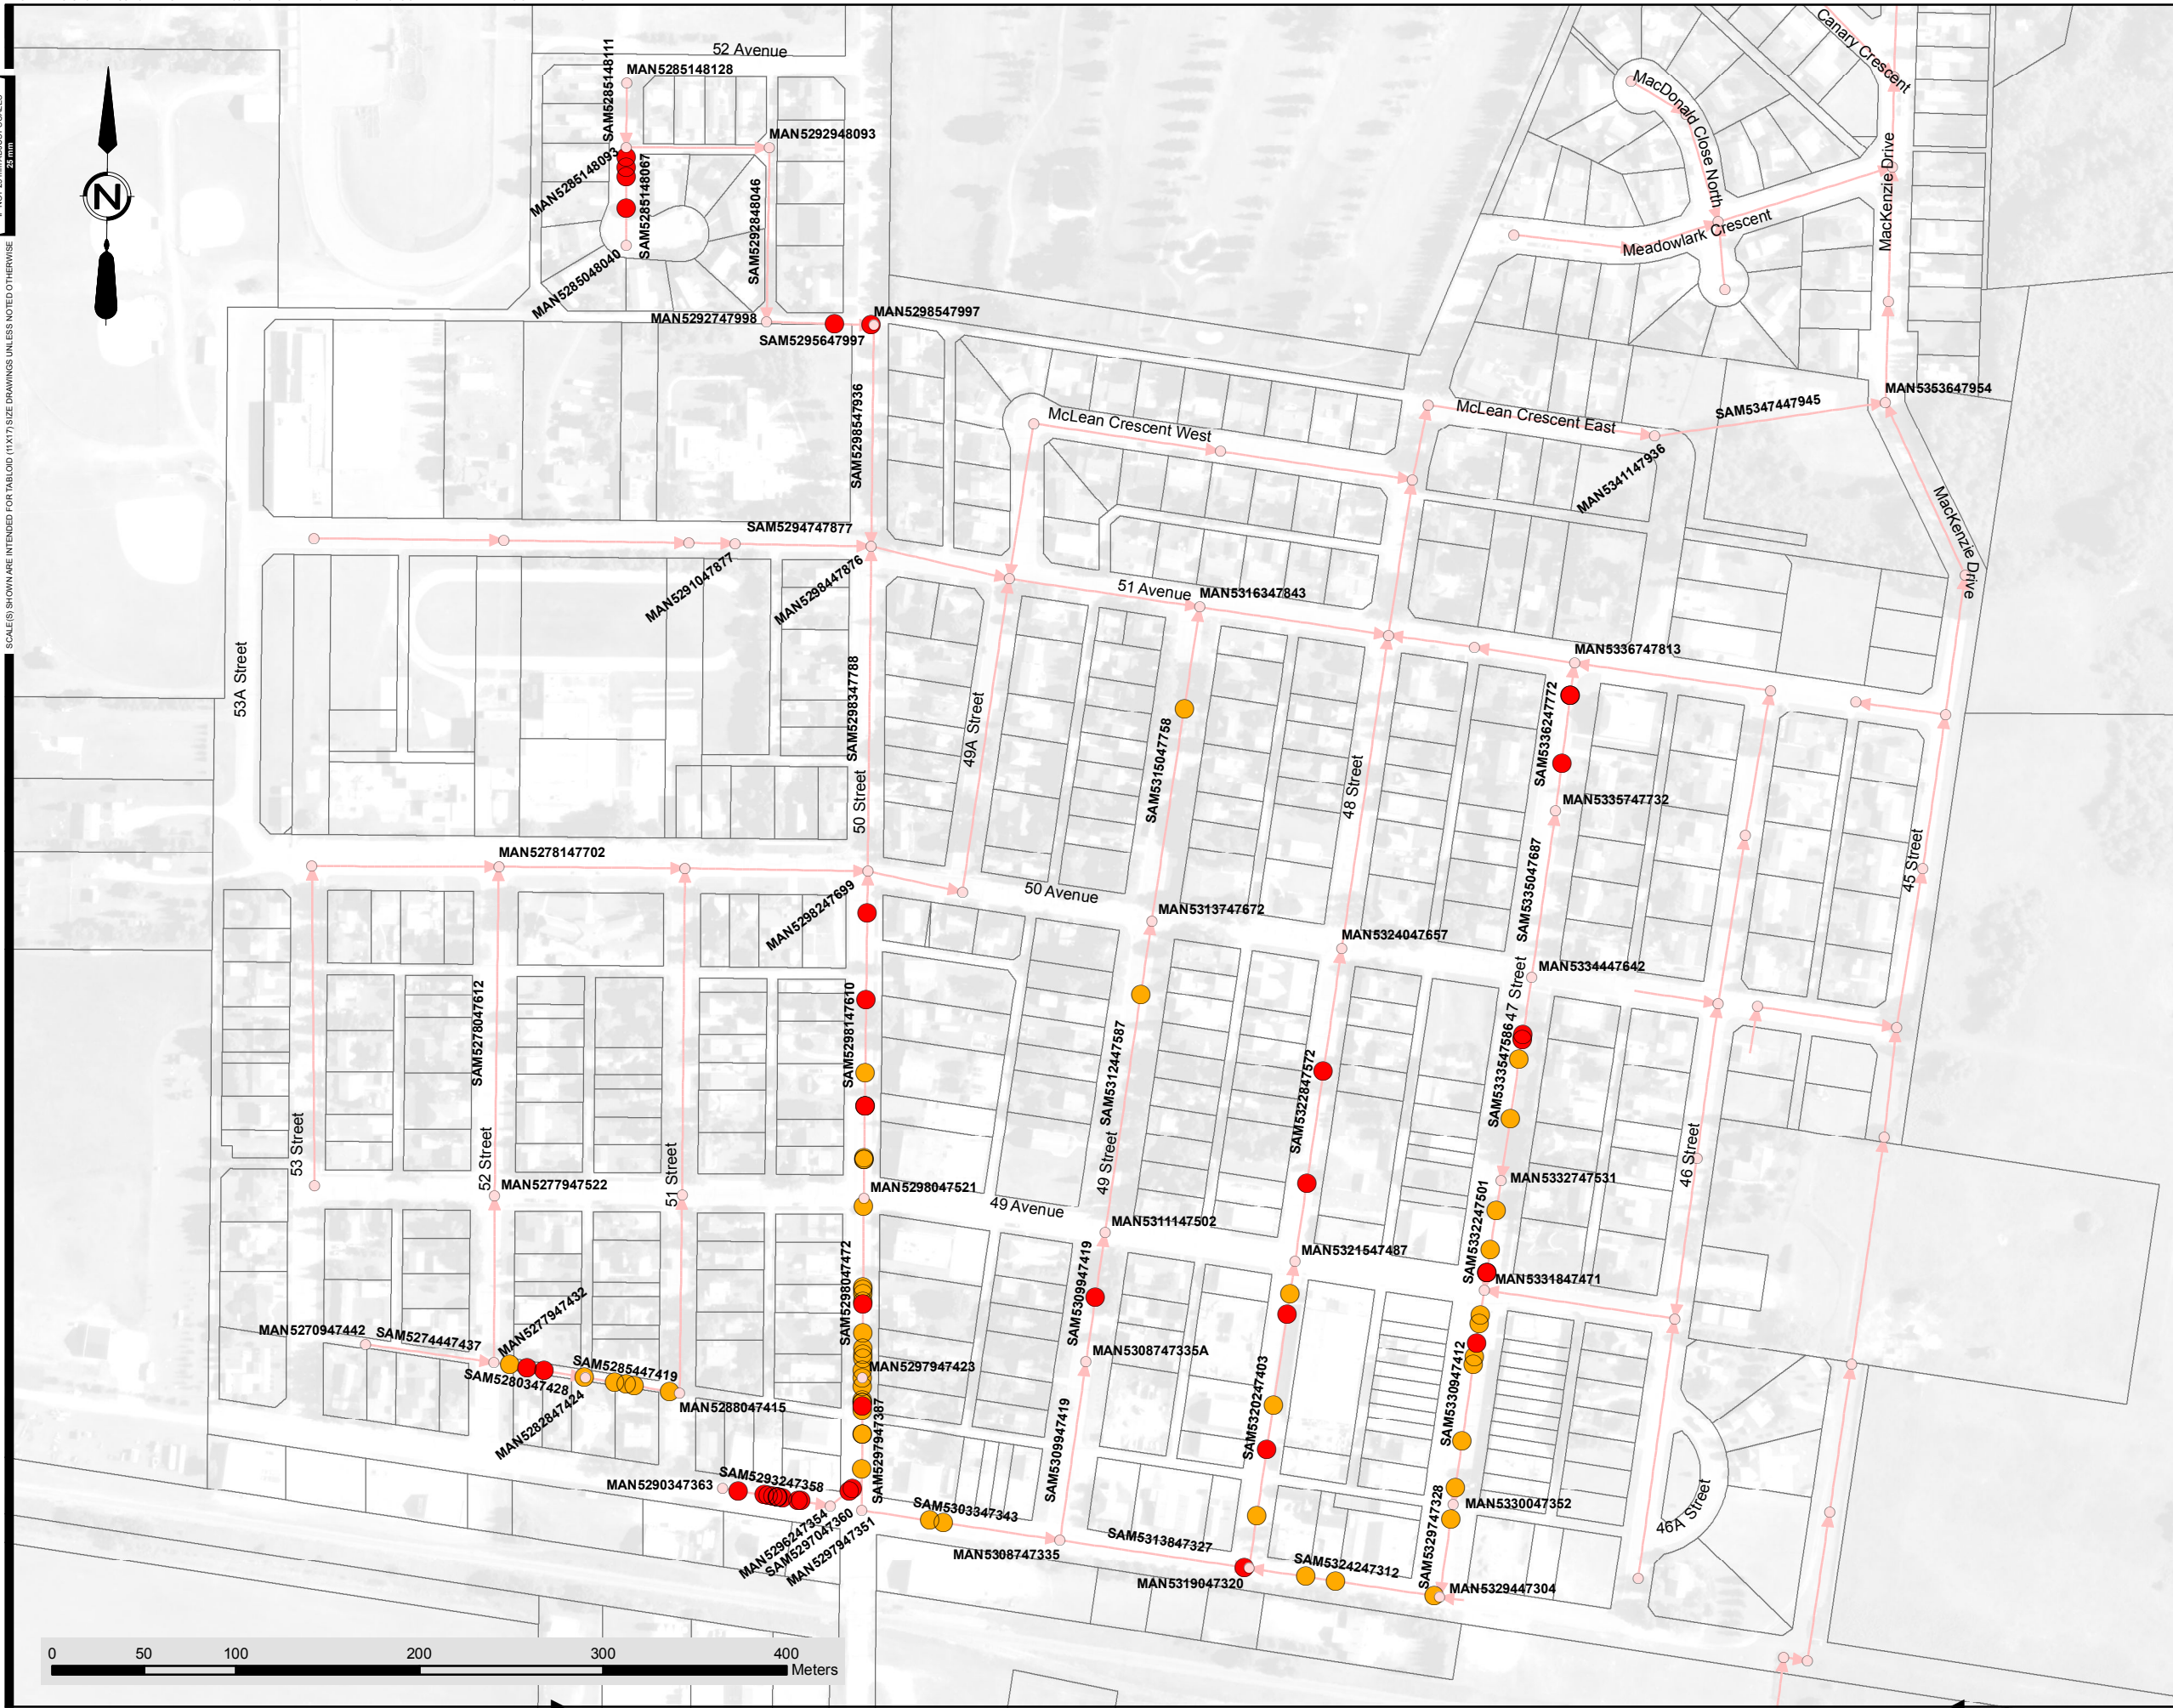
FIGURE No. 2A

We imported the defect data provided by Cam-Trac into ArcGIS and mapped the results, as shown on **Figure 2A** (enclosed). **Figure 2B** (enclosed) illustrates the two most severe types of defects: broken pipe and cracking. The mainlines inspected are predominantly clay tile pipe; the areas with PVC mainlines were not inspected in 2018.

The following recommended actions are proposed based on the CCTV results categories presented on **Figure 2A**:

| • Broken Pipe / Structural Defect, Cracking | Remove and Replace |
| • Sag, Joint Offset / Separation | Ongoing Monitoring |
| • Intrusion / Obstacle, Deposits | Maintenance |
| • Minimal / minor defects noted | Reinspect in 5 Years |
